# Duct modification

Thai Kyowa Kako Co.,Ltd.  
 Waste Gas Treatment System Design and Manufacturing

# Workplace Improvement

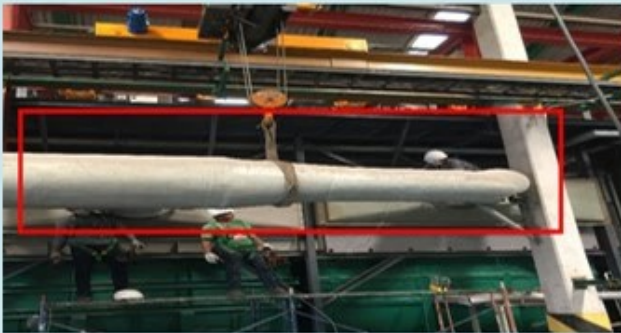
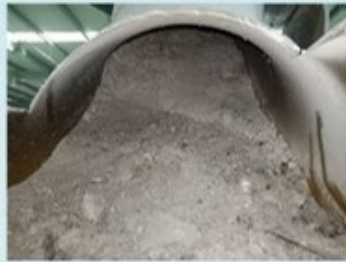
**Problem:** There was a problem with the duct size because the exhaust was not vented well.

**Improvement:** Redesigned and changed to an appropriate duct size.

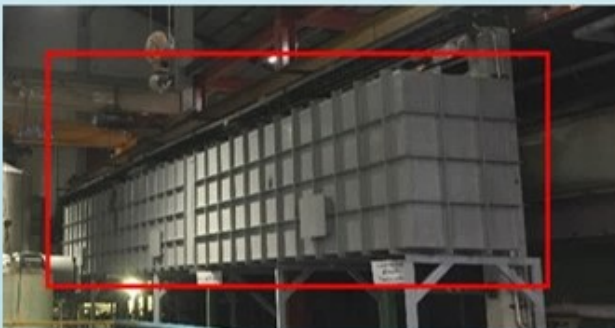
**Problem)** Gas mist diffused from part of production equipment in the factory  
**Improvement)** A local partition (clear PVC) was installed so that it can control the diffusion.

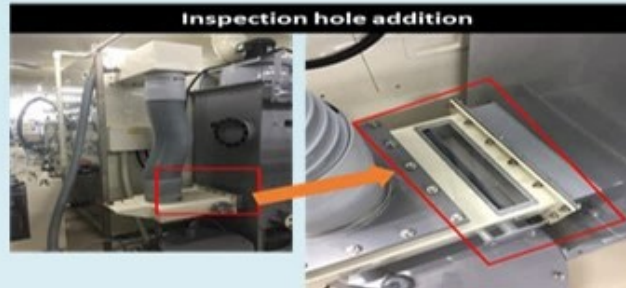
**Problem:** Exhaust damper is clogged, cause reducing capacity  
**Improvement:** Installed Clear PVC peep damper. Changed to visual check for clogging in the damper

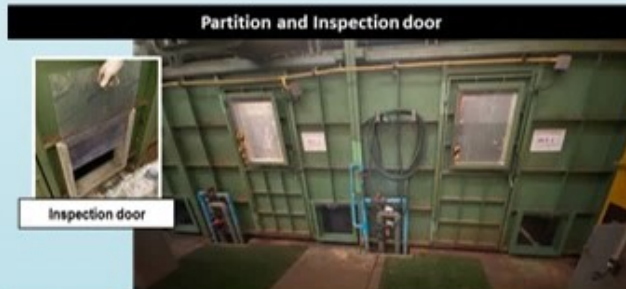
**Problem:** Liquid mist spreads  
**Improvement:** All partitions and inspection doors was made from FRP to prevent corrosion as the safety measure.

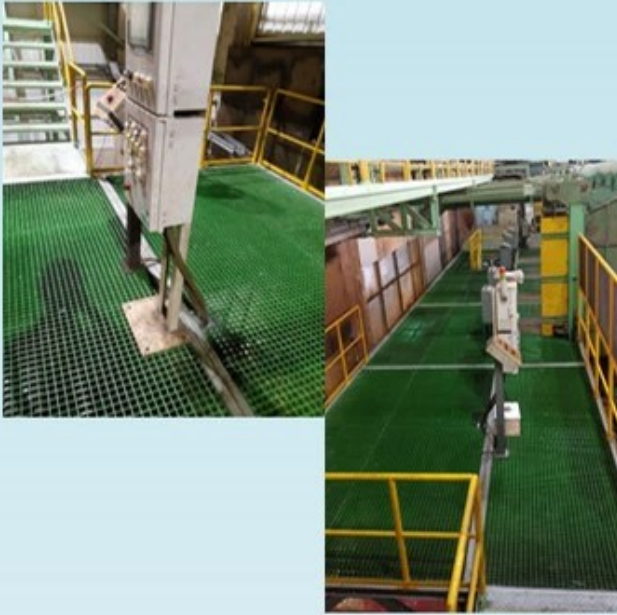
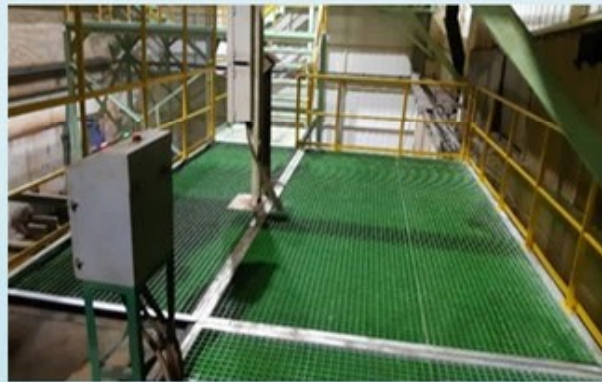
## Change Grating floor

**Problem:** Shabby and rusty

**Improvement :** Renew to PP grating to prevent rust, corrosion and anti-slip.

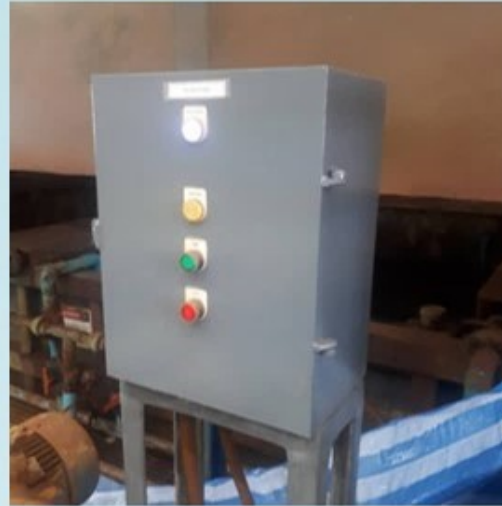
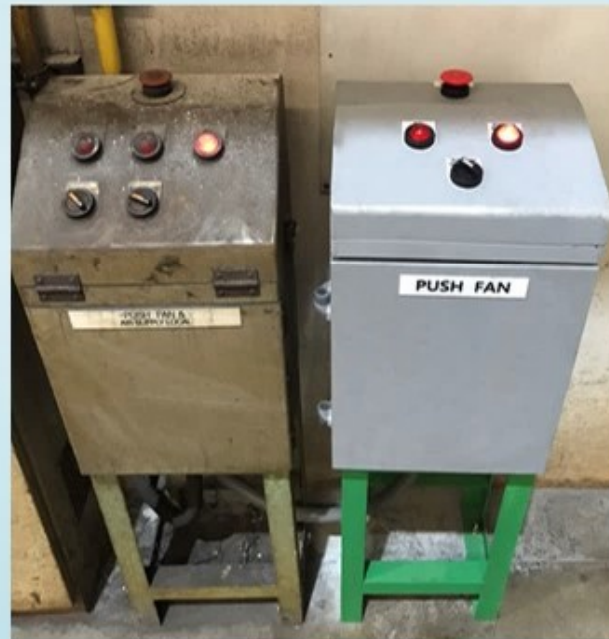
## Control Box ( PVC )

**Problem :** The control box made of steel was rusty

**Improvement :** Changed PVC control box.

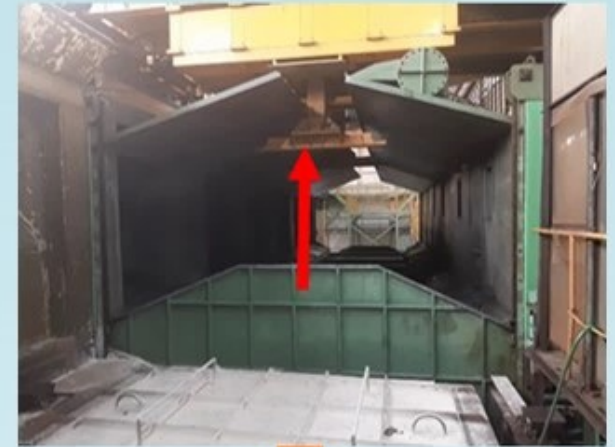
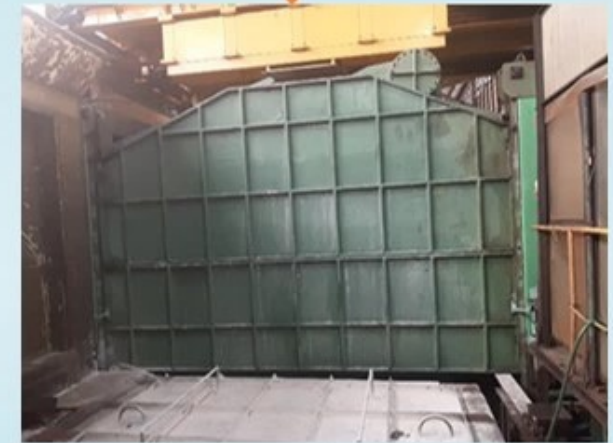
## Auto Shutter

The chemical mist was diffused and the surrounding area was corroded.  
(Improvement) Installed an automatic shutter to prevent mist scattering and improve the environment.

The automatic shutter was made from FRP, lightweight and sturdy.
